Assessing Sedimentation Issues within Aging Flood Control Dams, Oklahoma

By Sean J. Bennett and Charles M. Cooper

Research Report No. 15

A preliminary report prepared for the USDA-NRCS, Stillwater, OK

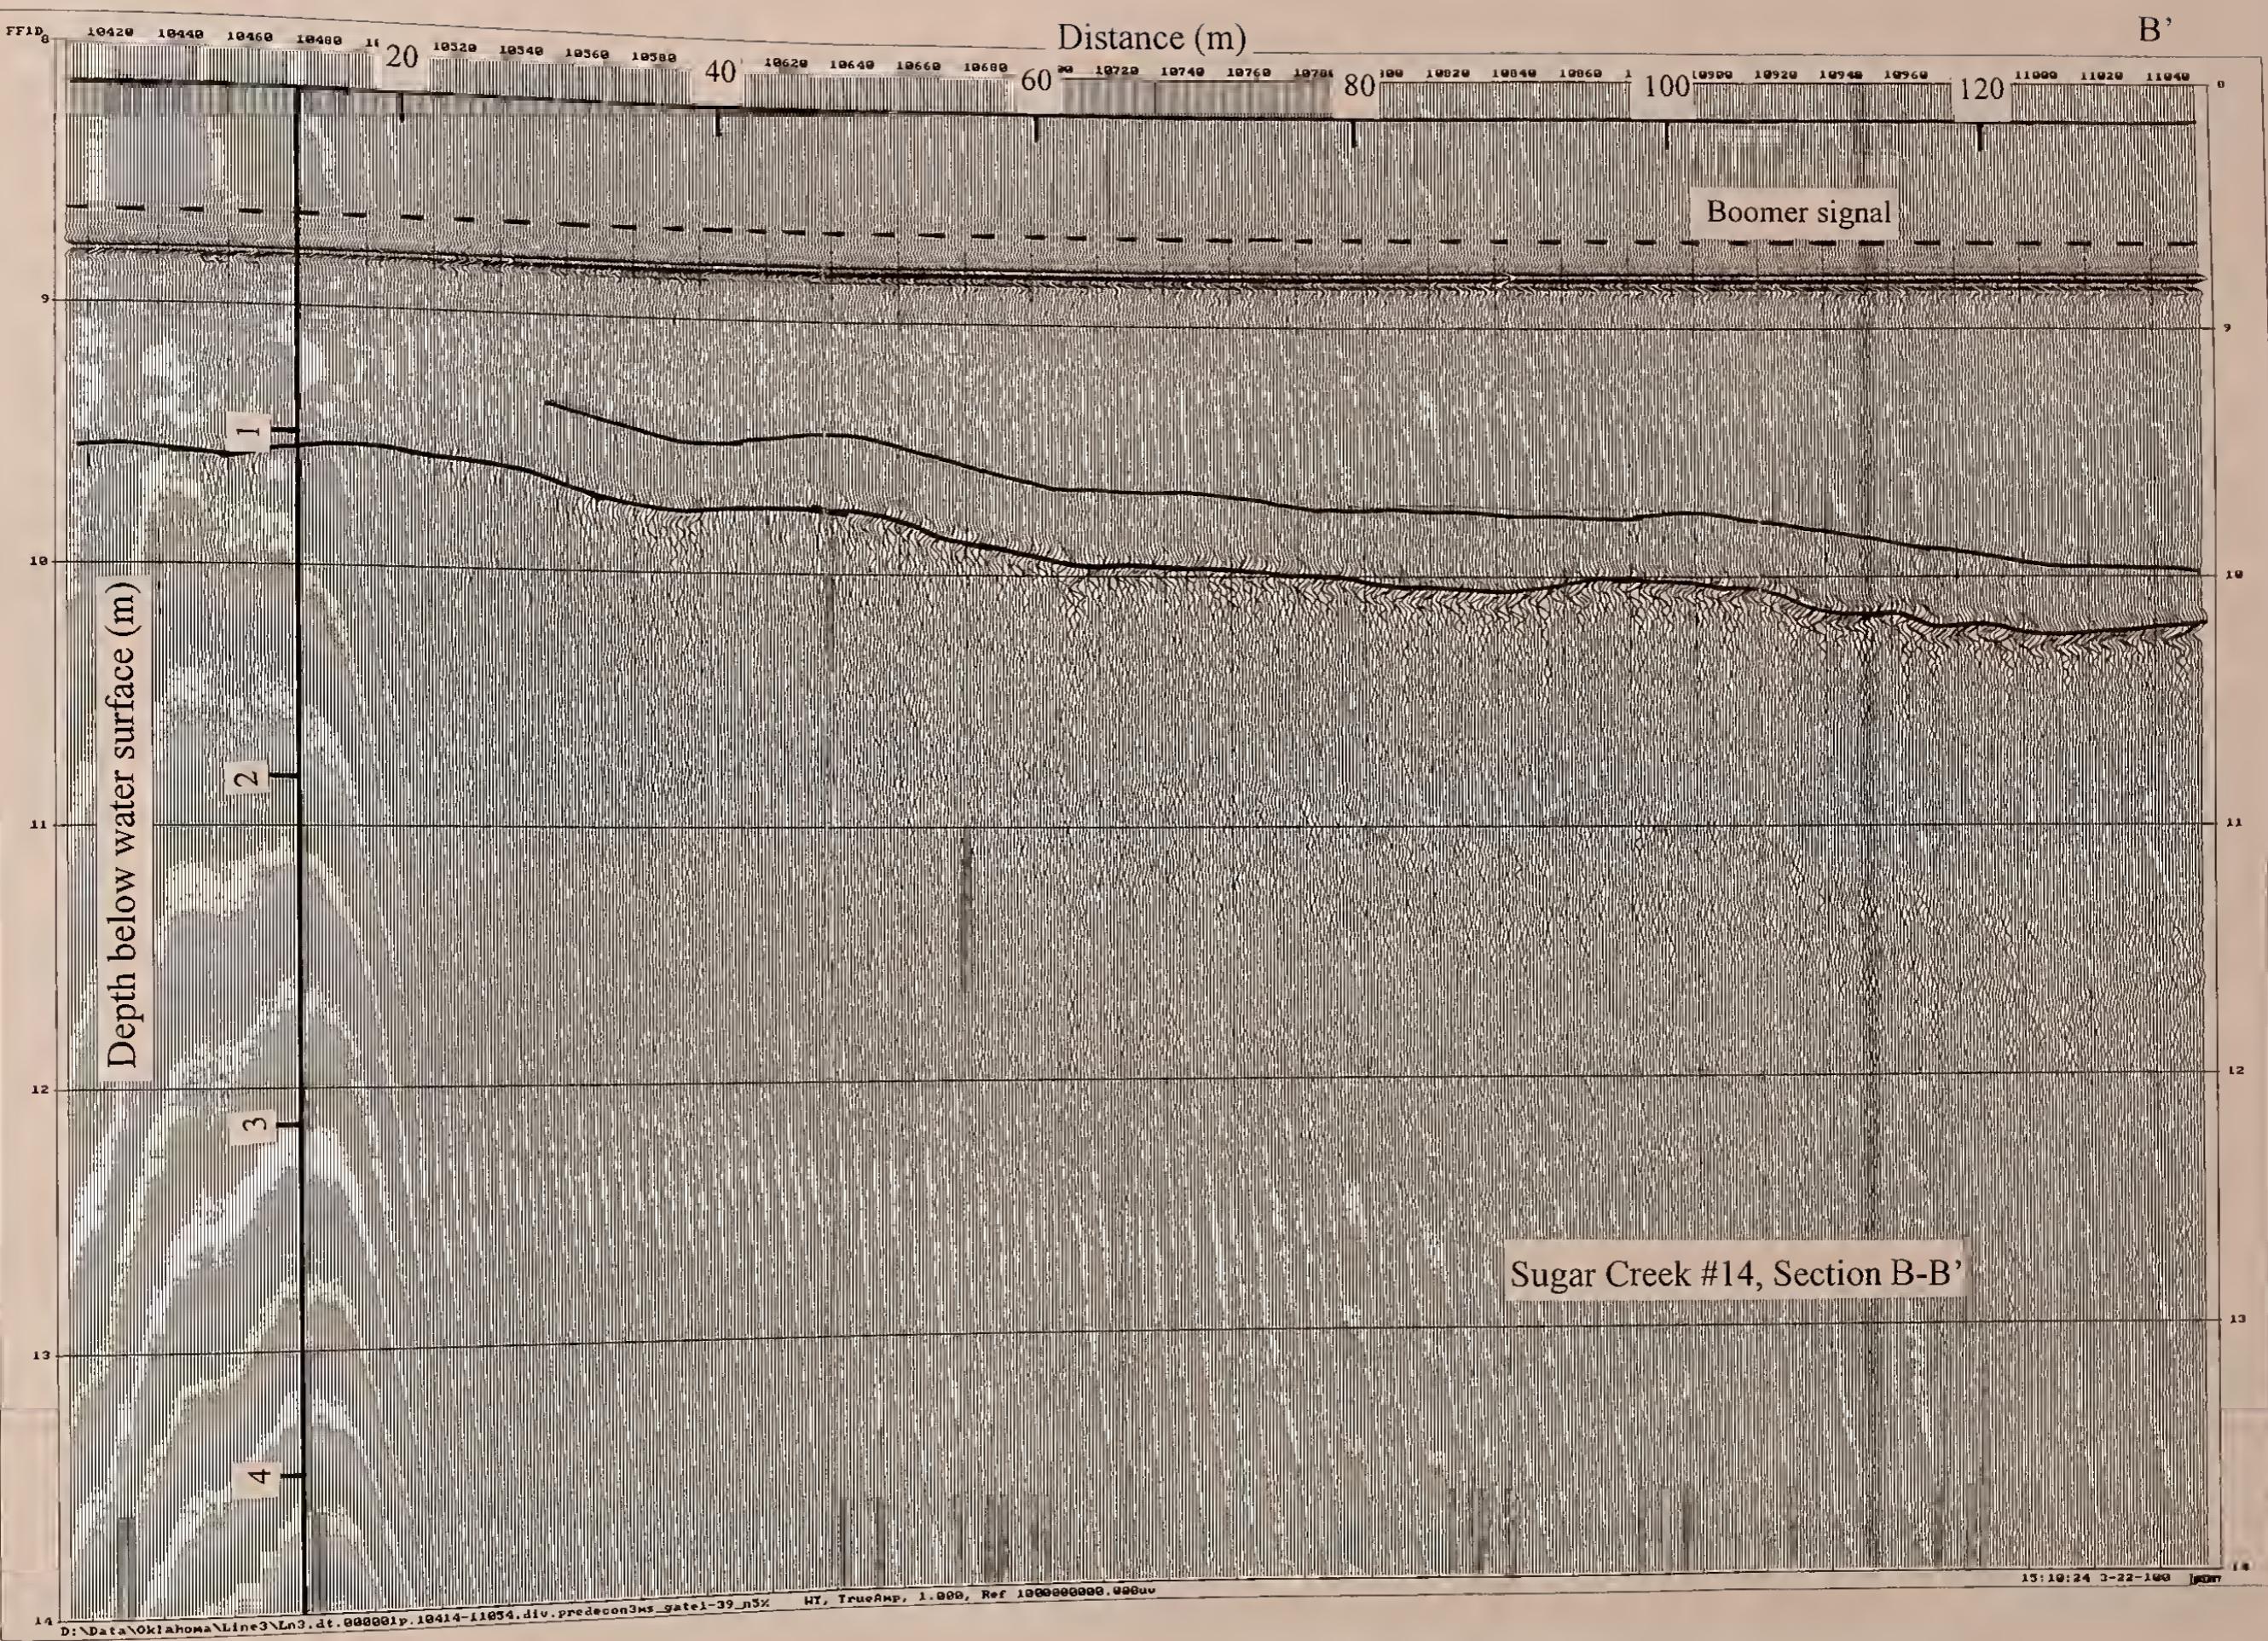
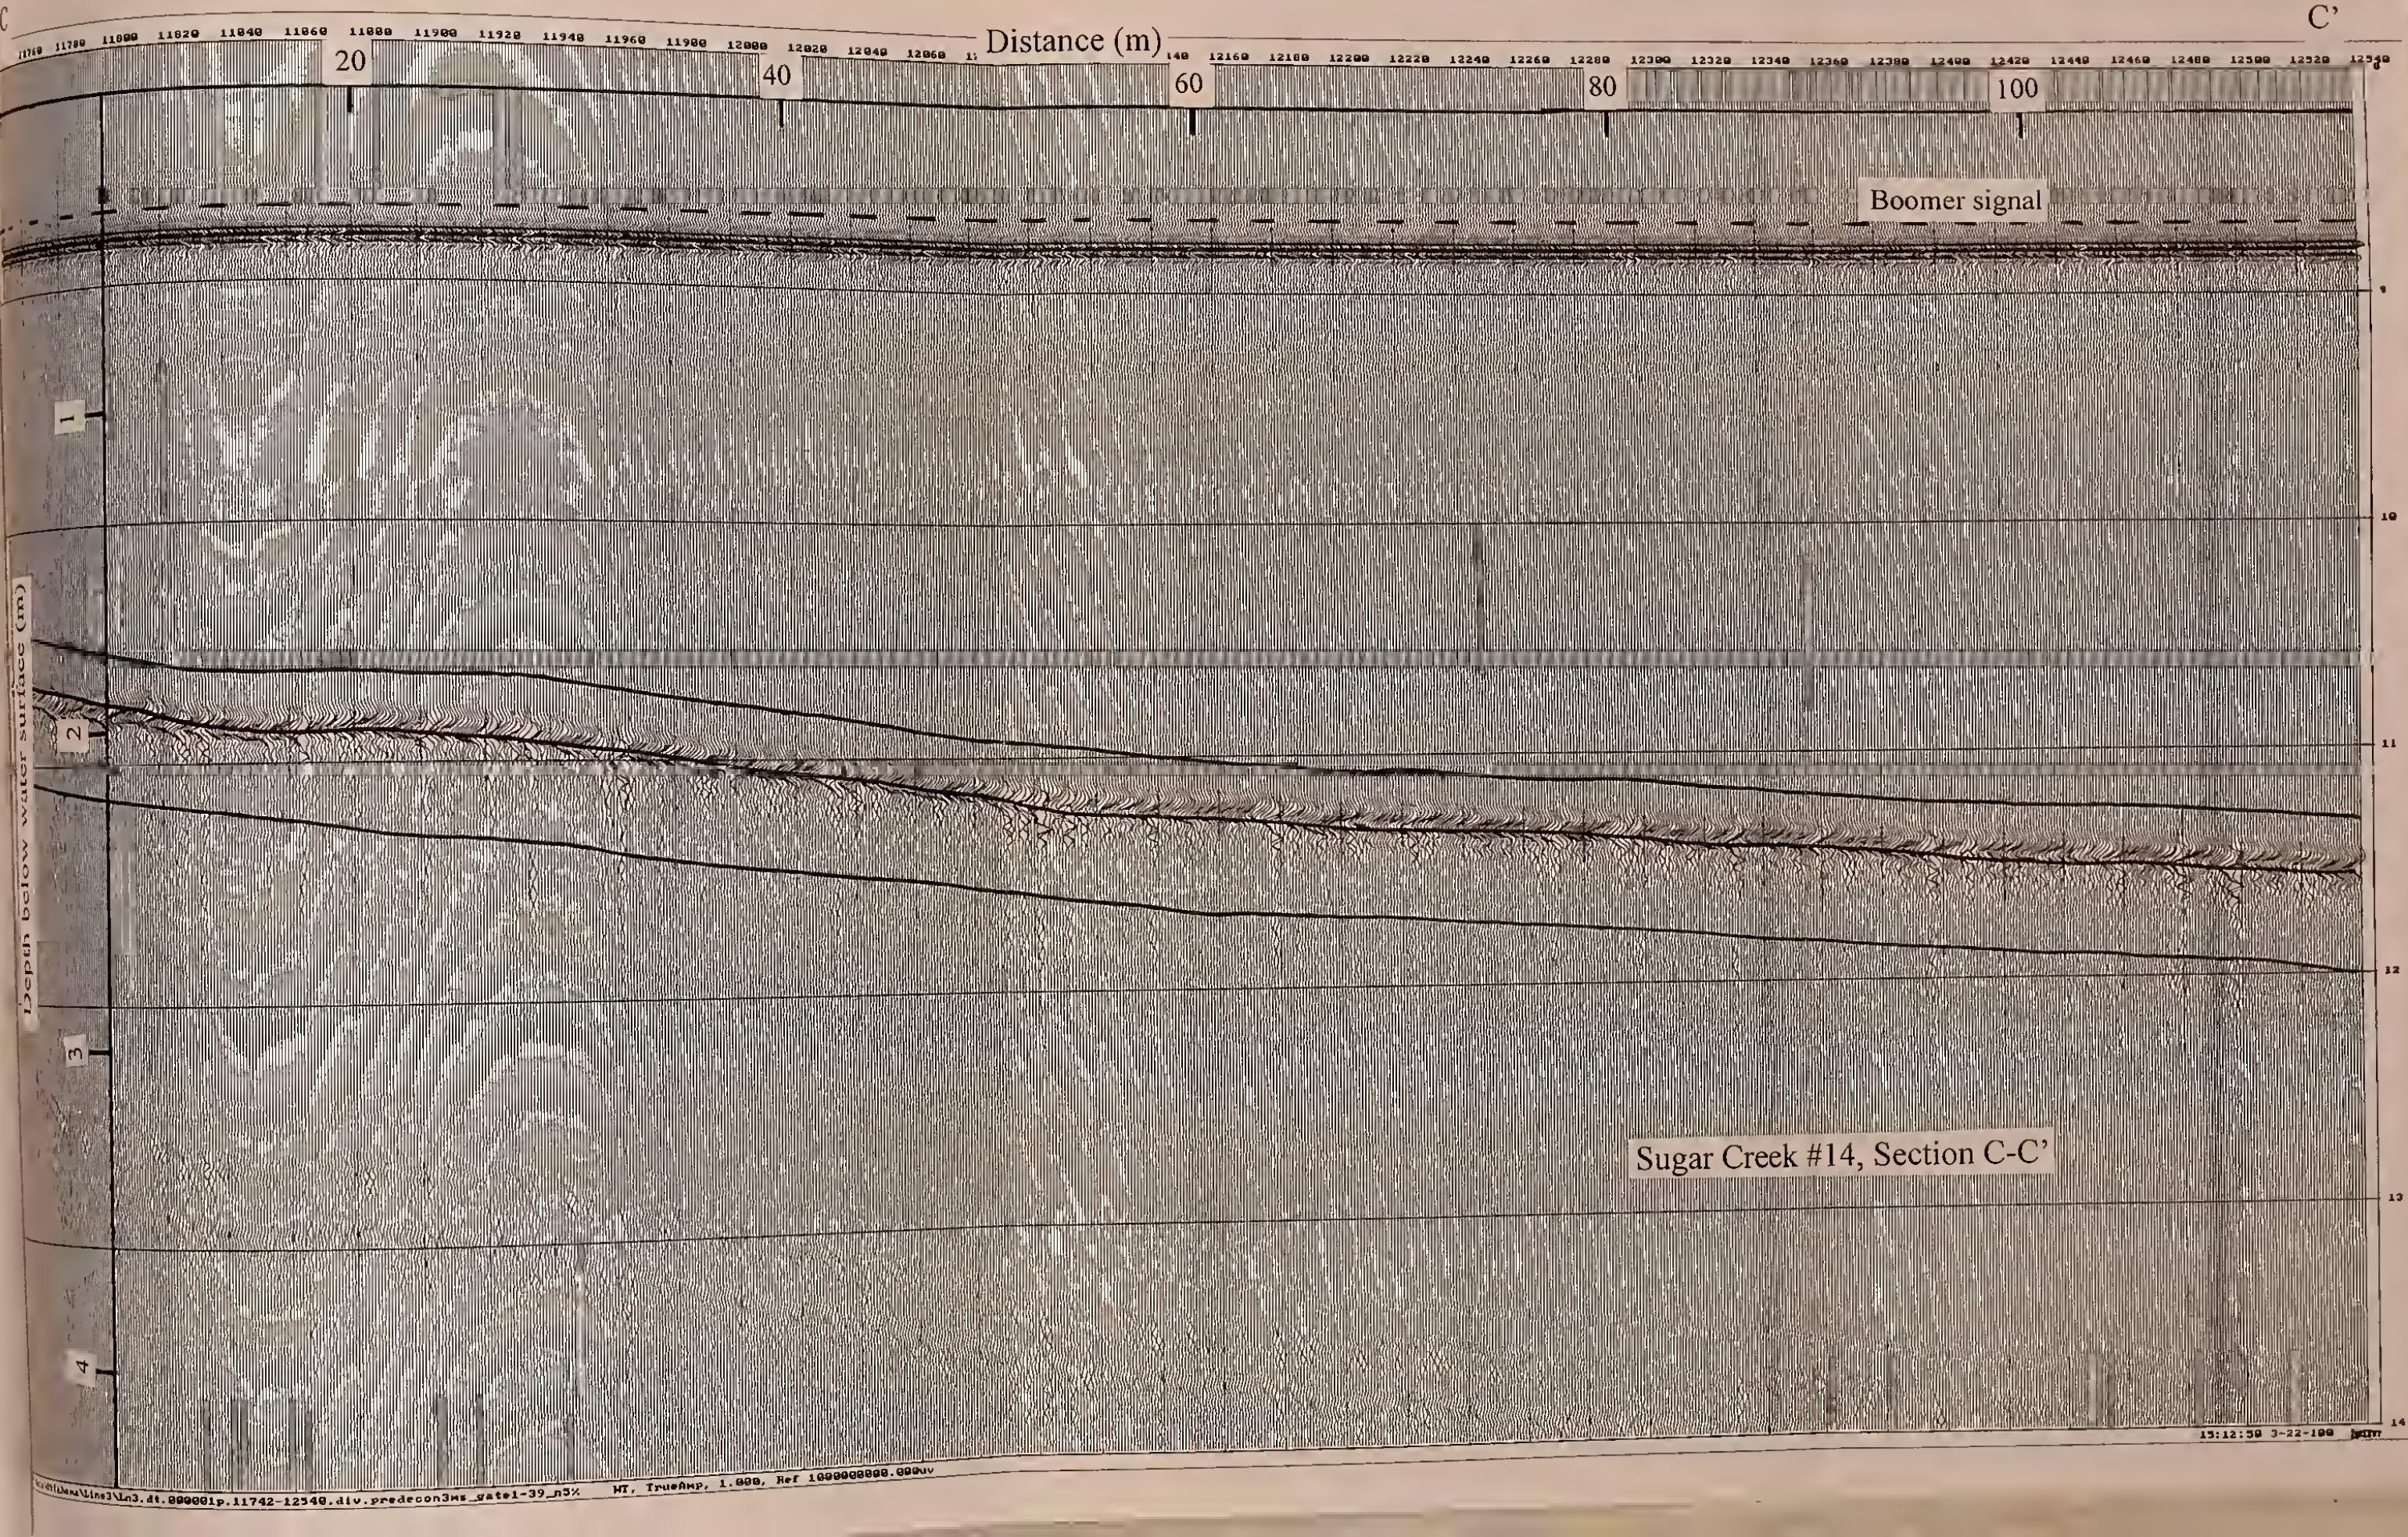
In general, the following observations can be made. The sediment near the water-sediment interface is quite soft, and it is represented by weak or low-amplitude reflectors, similar to Sugar Creek #12 (Figures 3-10, 3-11, and 3-12). This near-surface reflector is about 0.2 m thick, and it displays little variation in thickness across the basin. Some thinning of this unit occurs towards the principal spillway (towards A'; Figure 3-10). At a depth of approximately 0.2 m, a very strong seismic reflector is observed, and this reflector is ubiquitous in all the seismic records. This strong seismic reflector is similar in depth and character to the reflector observed at Sugar Creek #12, and the reason for its presence is still unknown. Few deep seismic reflectors were observed. But in Figure 3-10 and Figure 3-12, a reflector is observed at depths of 0.6 and 0.5 m, respectively, and the thickness of this reflector is about 0.3 m. At present, the reason for this deep reflector is unknown.

Figure 3-11. Seismogram of section B-B' from Sugar Creek #14 (next page; refer to Figure 3-9). Dashed line is location of boomer (approximately 0.5 m below the water surface), and solid lines are seismic reflectors identified. Depth and length scales are shown, and total length of seismic record is 134 m.

Figure 3-12. Seismogram of section C-C' from Sugar Creek #14 (next page; refer to Figure 3-9). Dashed line is location of boomer (approximately 0.5 m below the water surface), and solid lines are seismic reflectors identified. Depth and length scales are shown, and total length of seismic record is 116 m.

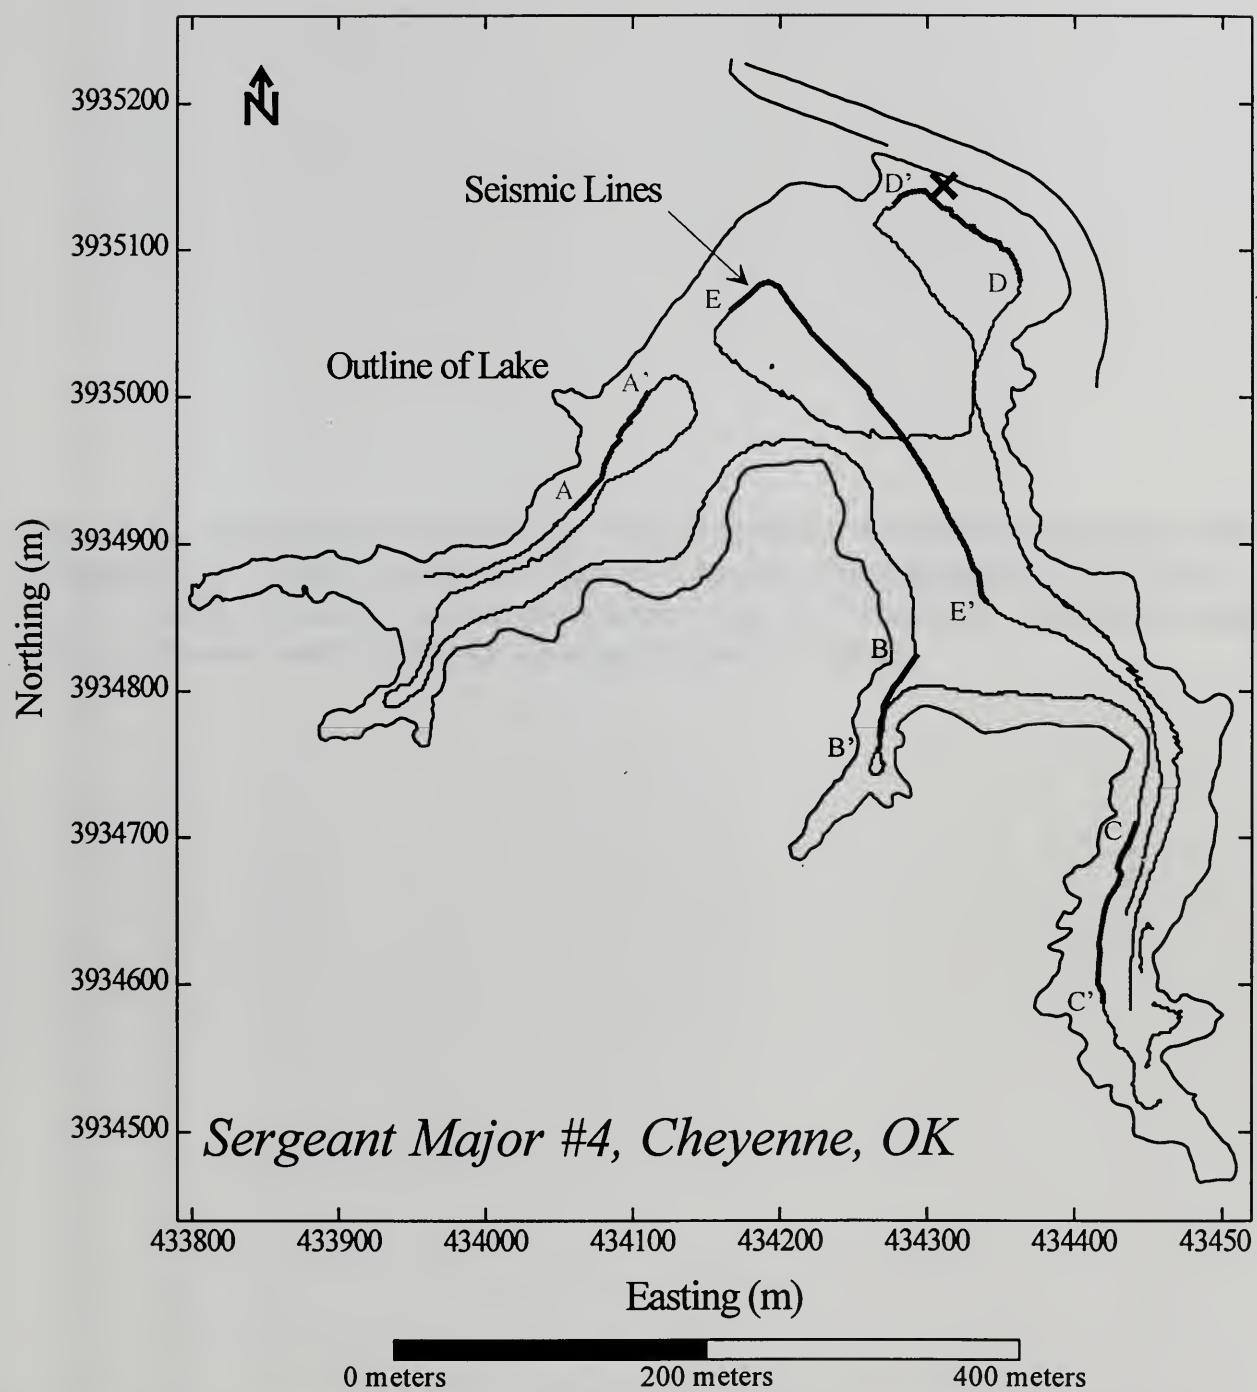
The reservoir bathymetry is relatively rugged as compared to the Sugar Creek sites with several topographic highs and lows. The deepest part of the reservoir occurs near the center of the lake, and maximum bathymetric relief is about 4 m. The presumable cause of this topography is the rock outcrops observable above the water line.

Figure 3-13. Base map of Sergeant Major #4 showing traces for all seismic lines. Five segments, labeled A-A', B-B', C-C', D-D', and E-E' are discussed in text. All positions are in UTM coordinates.

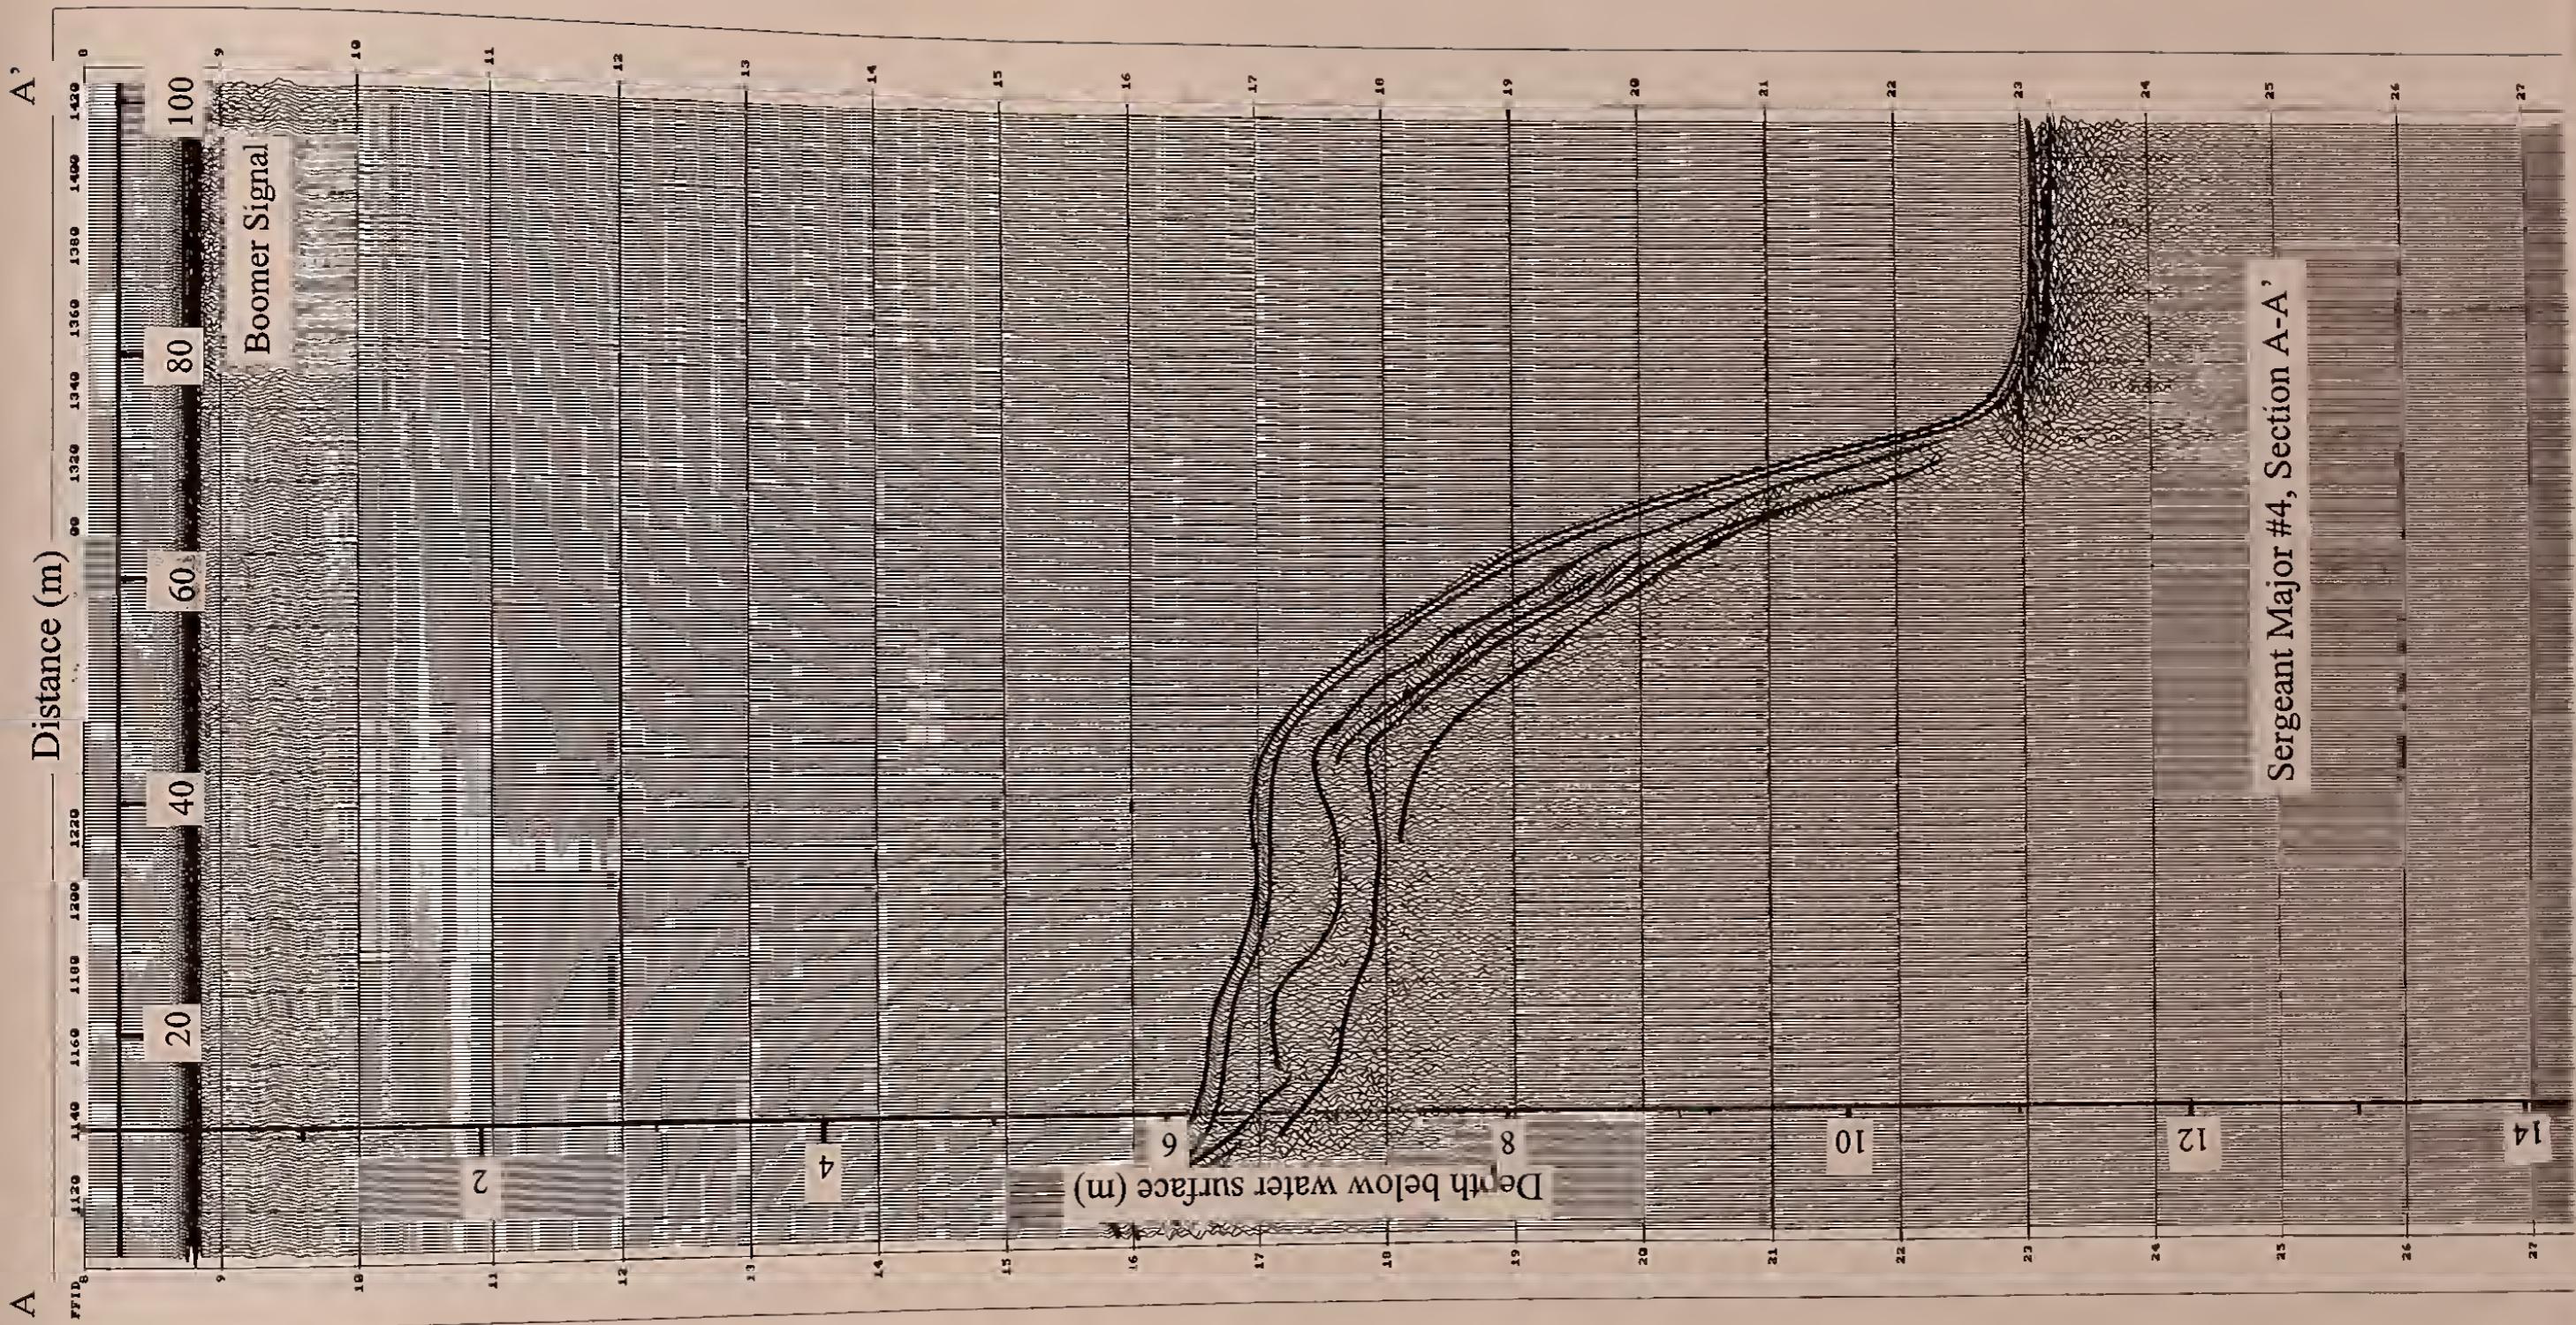
In general, the following observations can be made. The seismic profiles show a number of reflectors in the subsurface. Along the northwestern tributary arm, (section A-A'; Figure 3-14), reflectors range in thickness from 0.1 to 0.5 m, they occur at depths up to 1 m, they have variable inclinations, and they are observed to thin towards the deeper part of the reservoir. In this deeper region, the reflectors become horizontal and much thinner, less than 0.2 m thick. The deeper region also displays greater seismic reflectivity, suggesting a change in substrate grain size and composition.

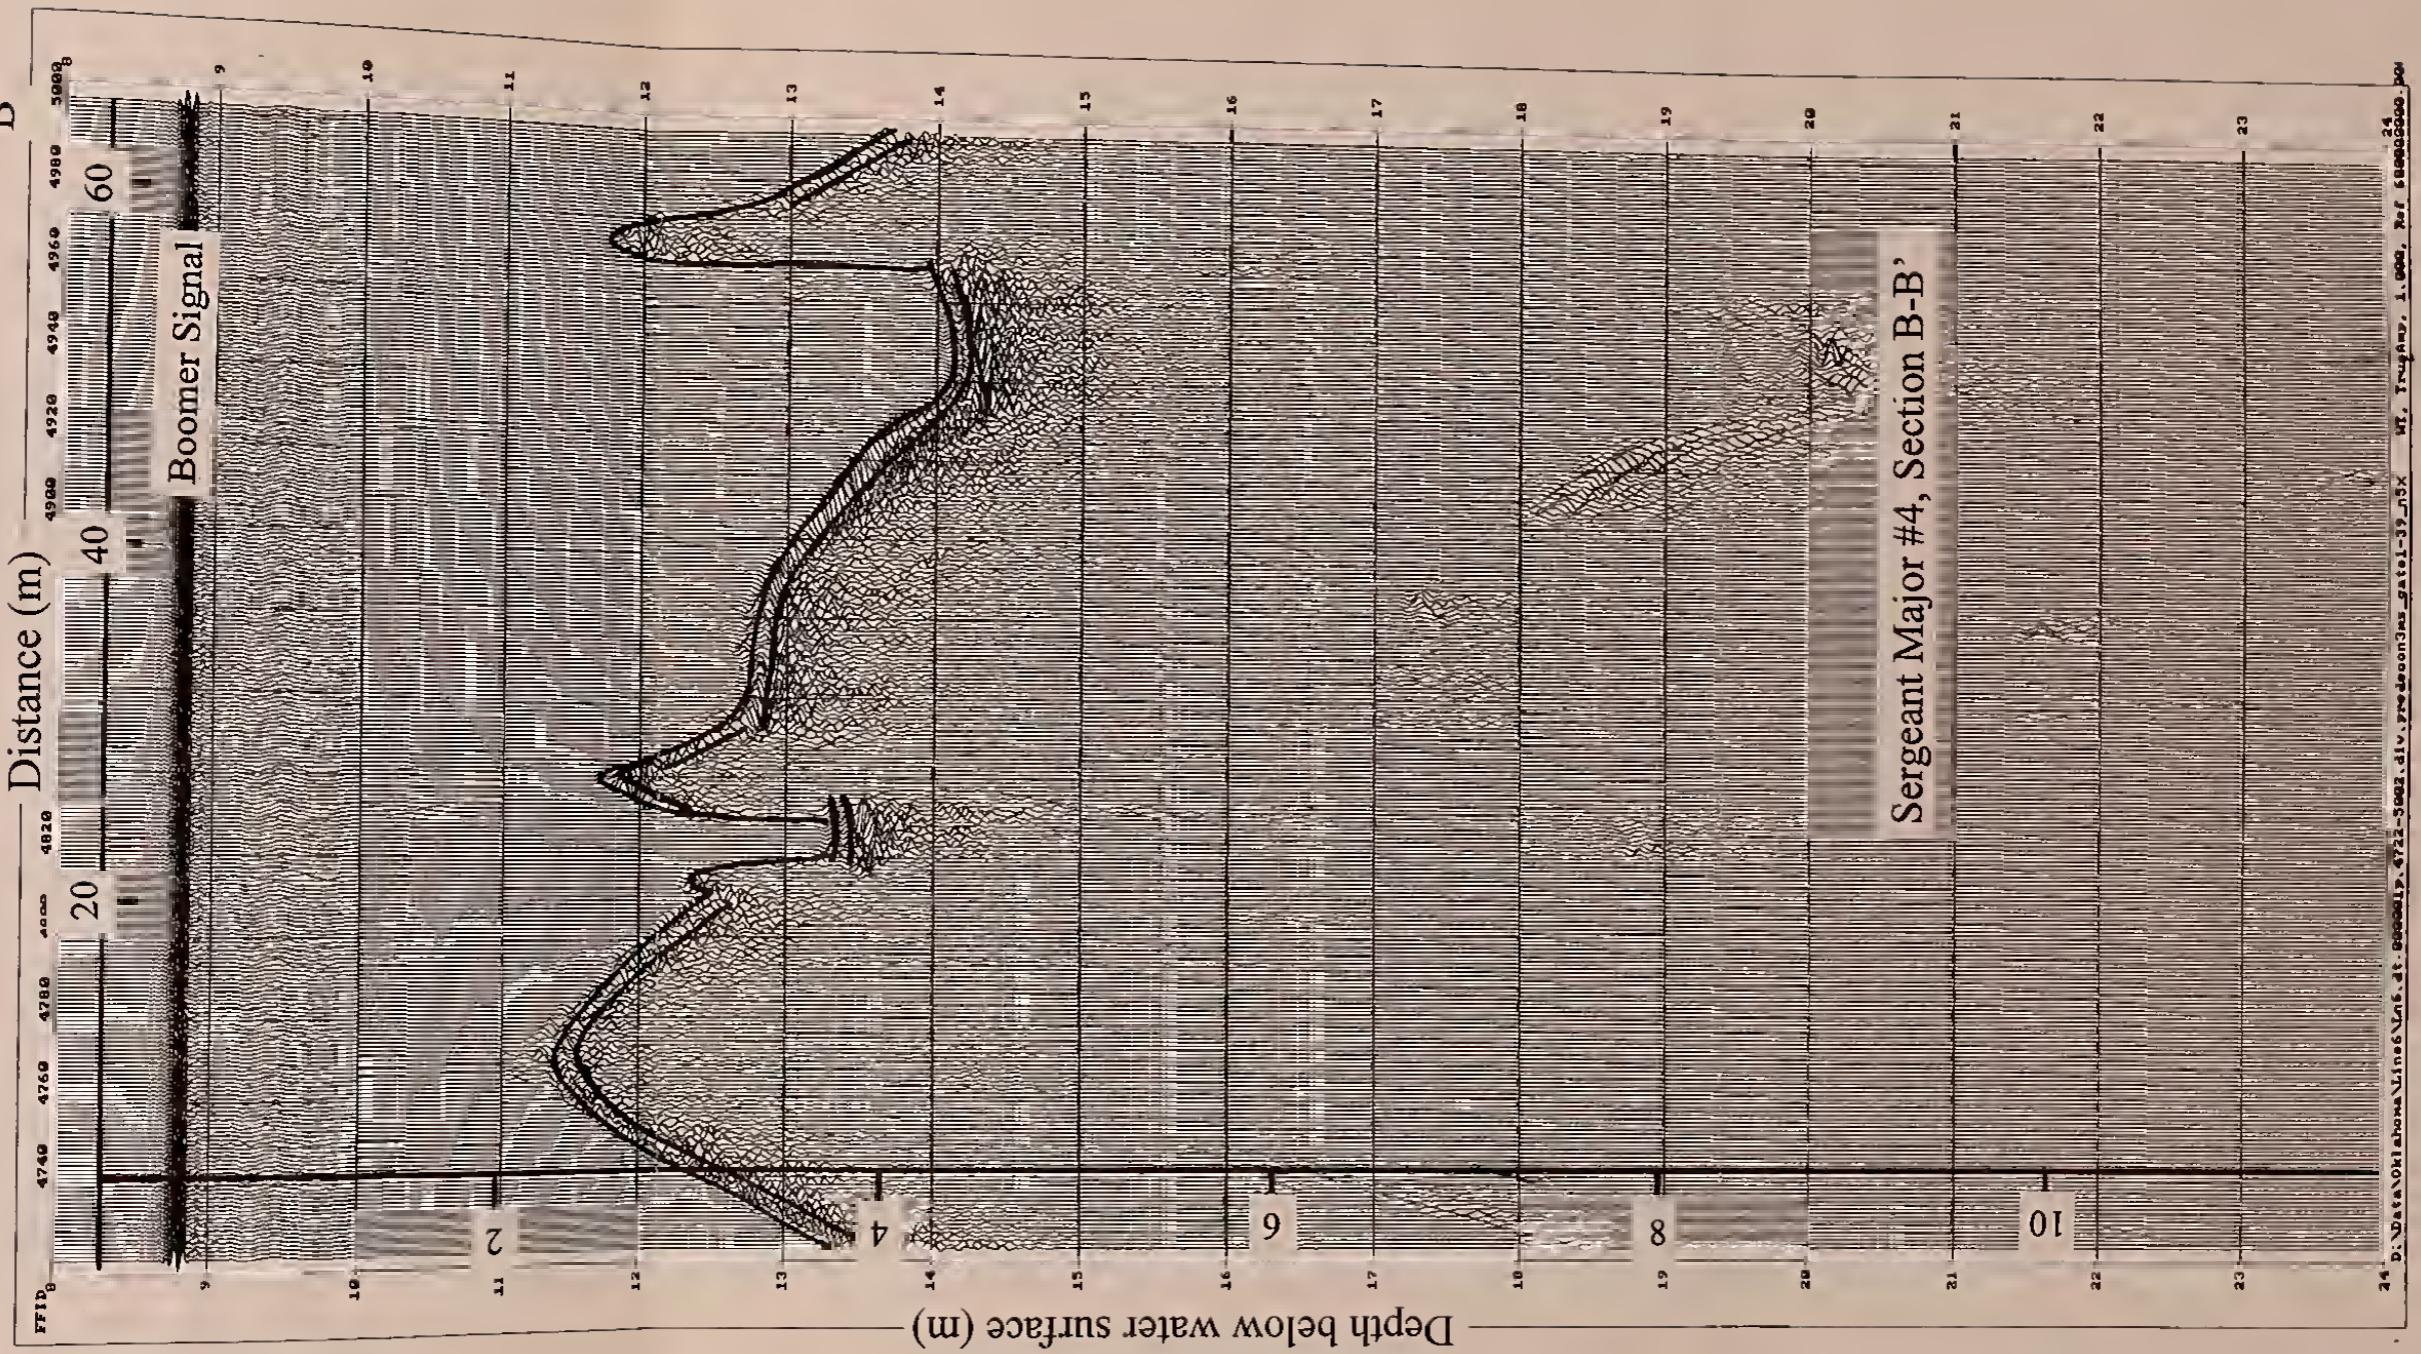
Similar reflectors are observed along the central tributary arm (section B-B'; Figure 3-15). But these reflectors are quite thin, about 0.2 m, they are restricted in depth to about 0.3 m, and they display little variation in thickness towards the deeper basin. Reflectors in the topographically low regions assume horizontal attitudes.

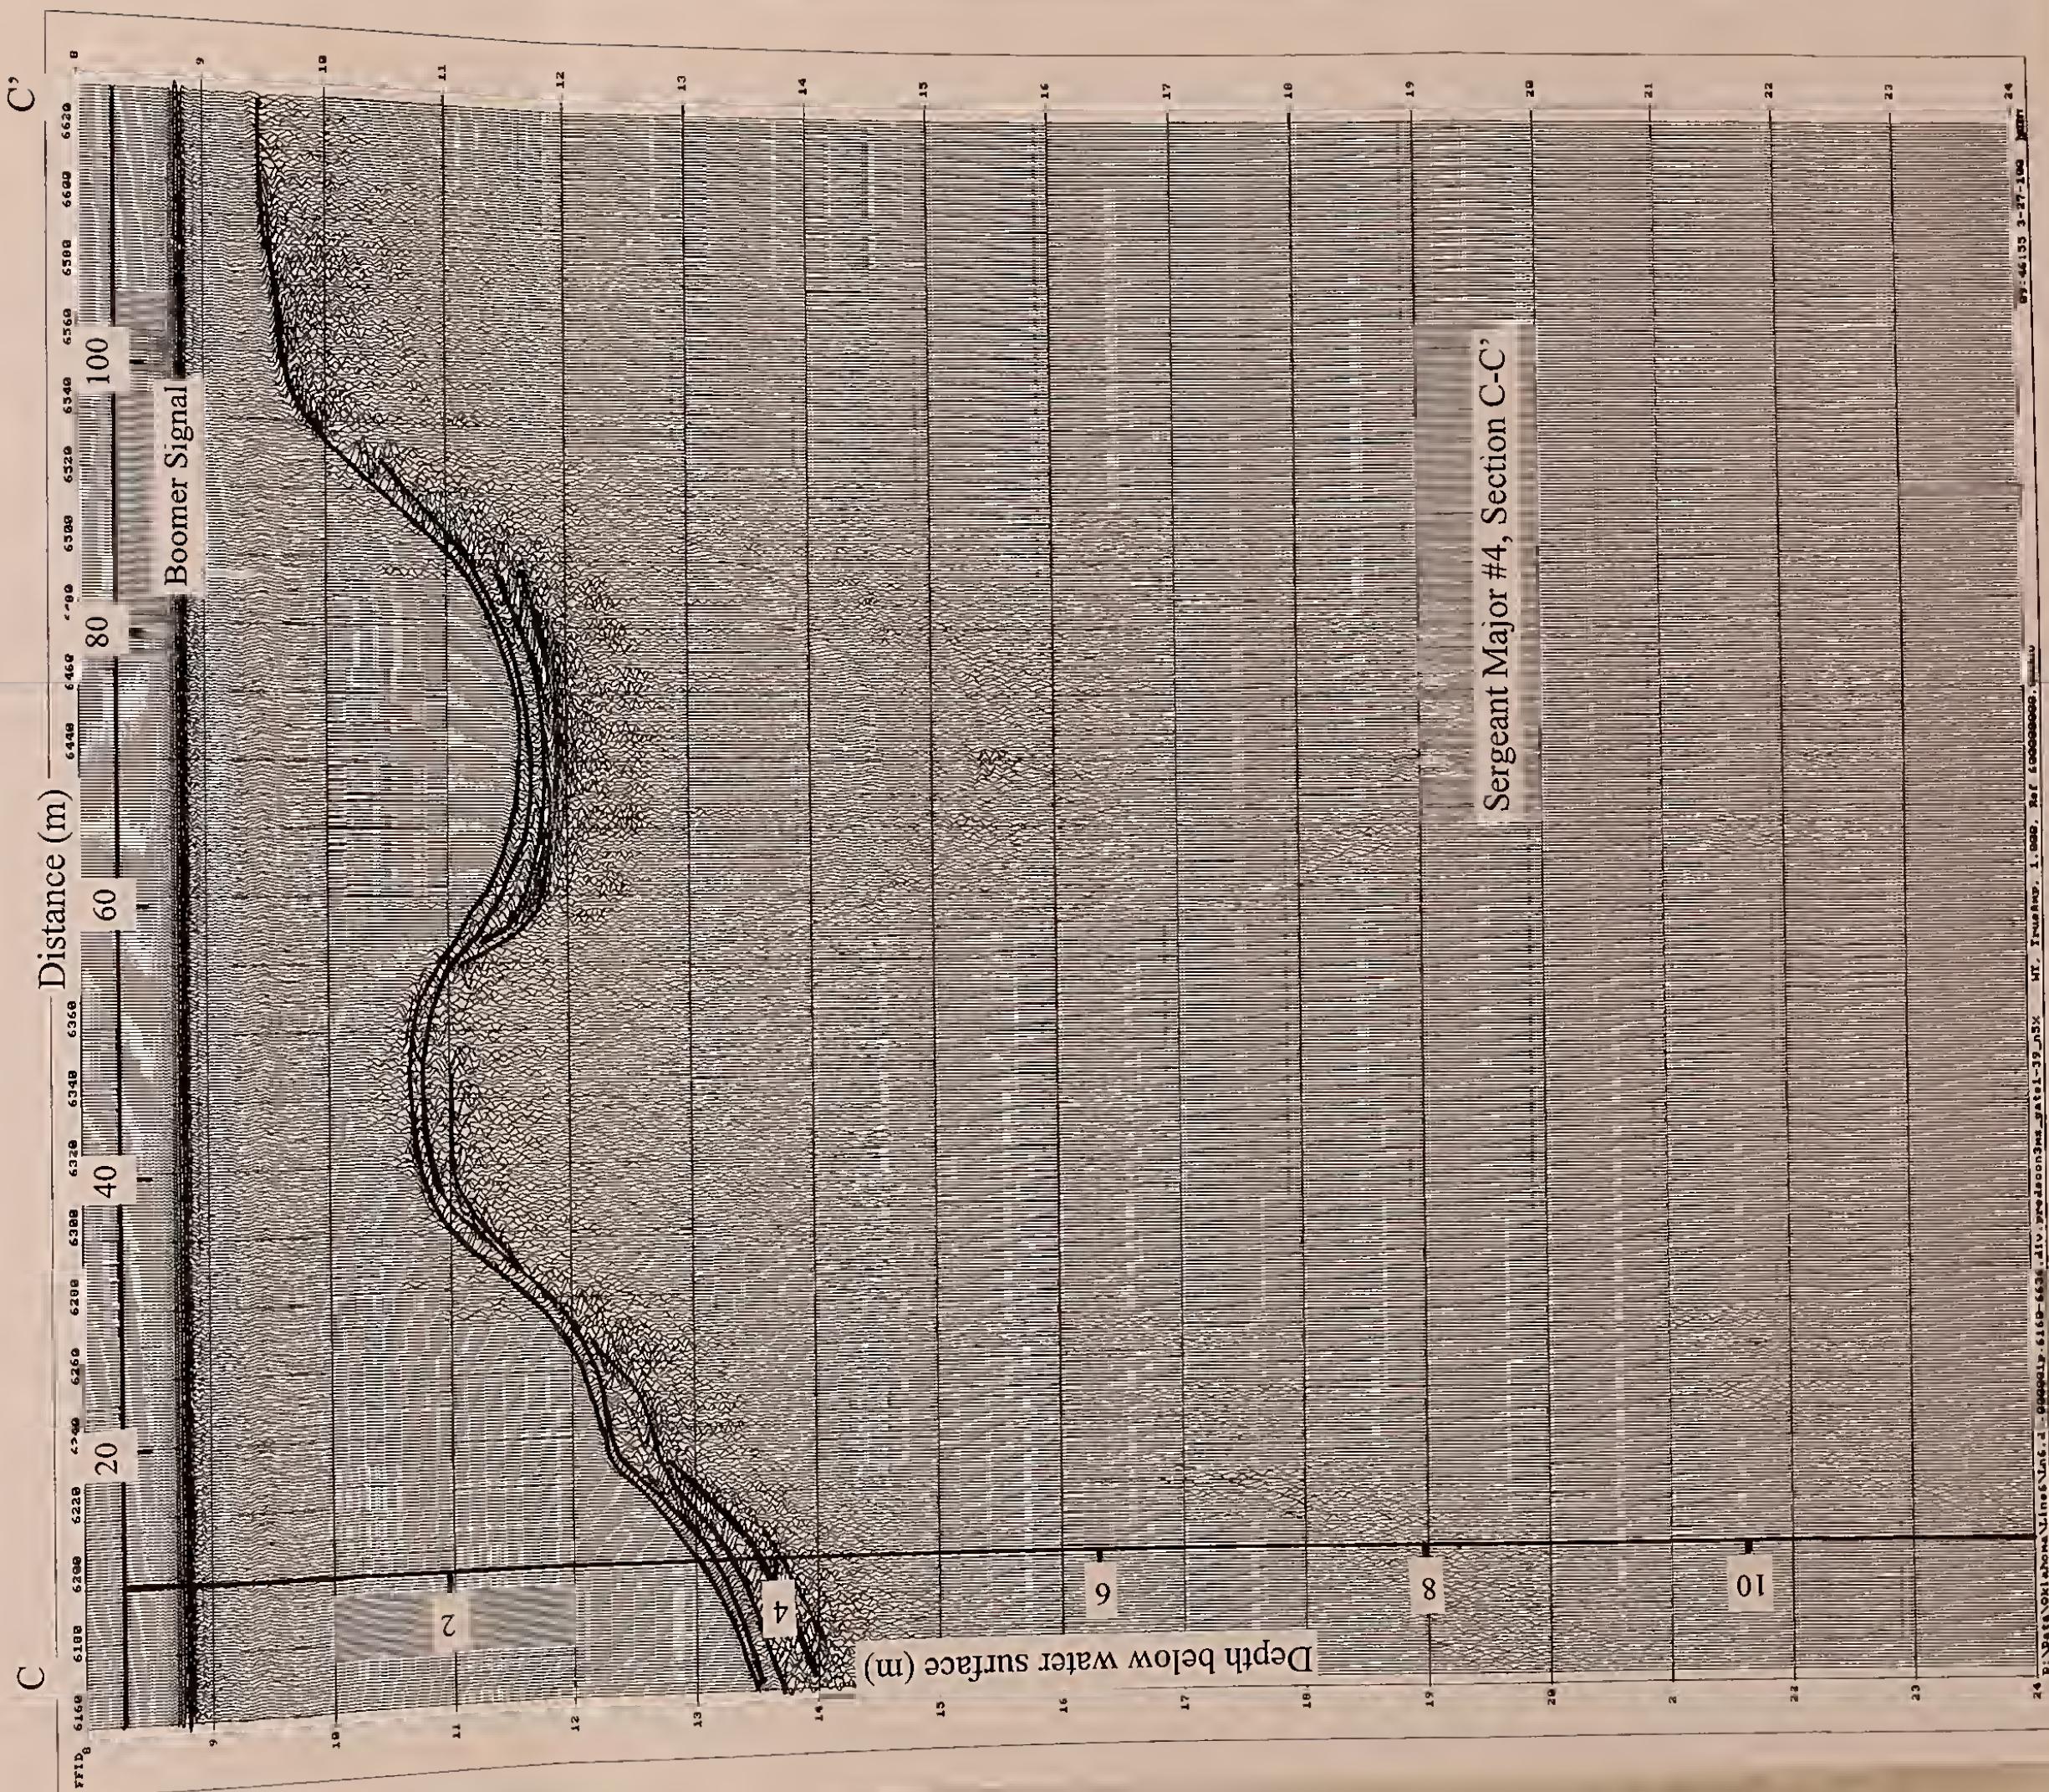
Along the southern tributary arm, (section C-C'; Figure 3-16), reflectors are more numerous in the topographically low regions, they range in thickness from 0.1 to 0.3 m, and they are restricted in depth to about 0.3 to 0.7 m. Many of these reflectors pinch-out towards the sides of the topographic depressions.

Figure 3-16. Seismogram of section C-C' from Sergeant Major #4 (next page; refer to Figure 3-13). Thick solid line is location of boomer (approximately 0.5 m below the water surface), and solid lines are seismic reflectors identified. Depth and length scales are shown, and total length of seismic record is 120 m.
